# UTAH STATE CAPITOL ARCHITECTURE: EXTERIOR SURVEY REPORT

ELEVATION LOCATION: SOUTH ELEVATION

Survey Date: 4/24/00

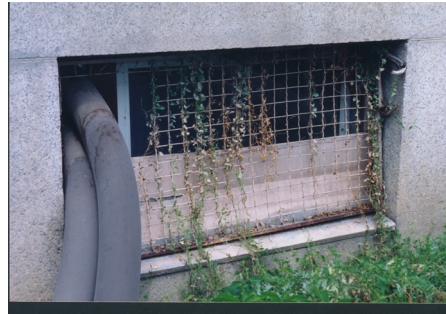
**Condition:** O

**Comments:** Screen cut for tubing, through ground. Metal Baking-paint chipping, various weeds/branches intertwined with screen. Half patch job, a tubes through window.

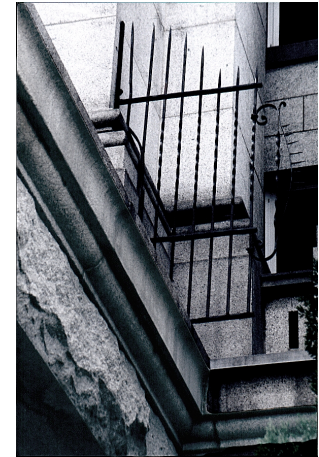
**Condition:** INT

Intrusive, non-original, non-essential element

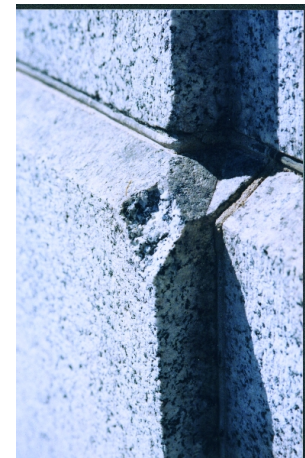
**Condition:** BR

Broken, severely cracked or chipped

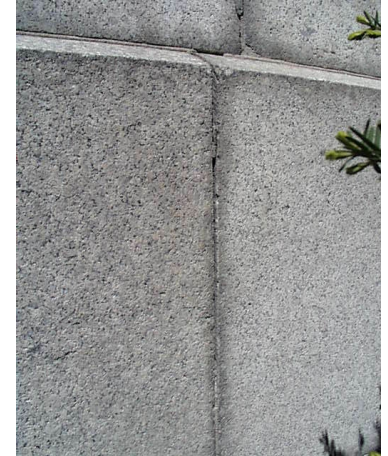
**Comments:** Corner chipped- above bevel striations which look like starts of cracking.

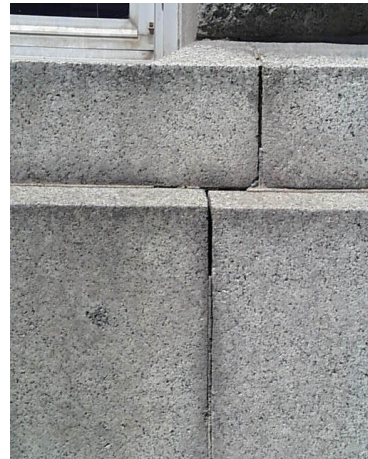
**Comments:** Mortar missing about 1'- damaged mortar also about 1'.

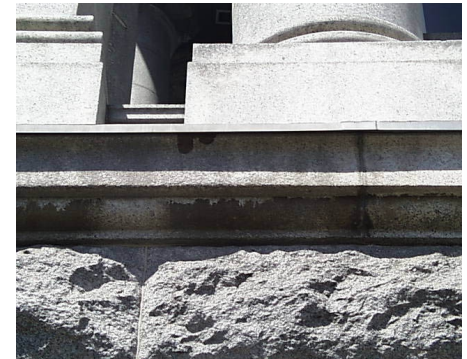
Significant Staining; may indicate rusted connector

**Comments:** Not sure of content of staining.

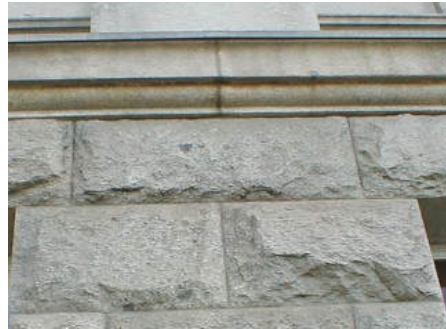
Broken element, mortar joint damage

**Comments:** Top and bottom of joint.

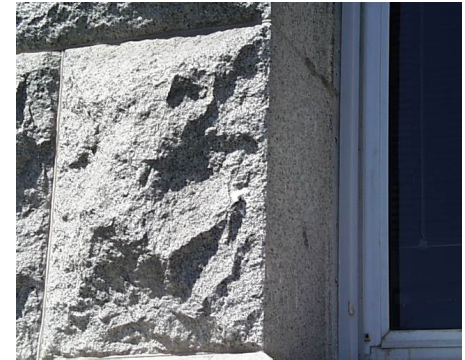
Mortar joint with missing or loose mortar

**Comments:** 2"

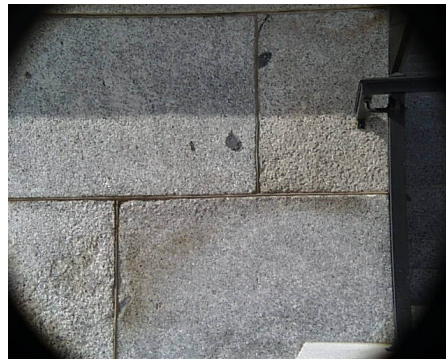
**Comments:** Seriously exfoliated surface at both sides of the guard rail.

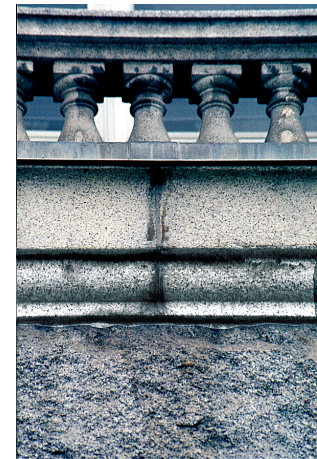
Significant Staining; may indicate rusted connector

**Comments:** typical

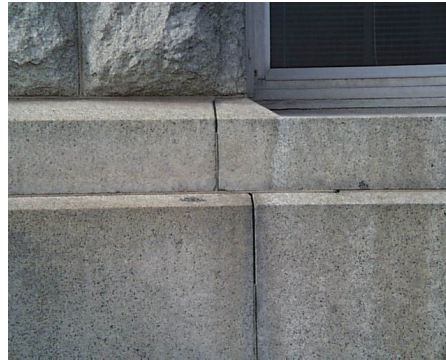
**Comments:** Most mortar joints of lower belt corse at both sides of the windows need repair.

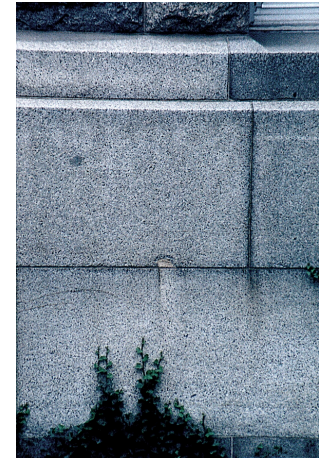
**Comments:** Loose mortar joint.

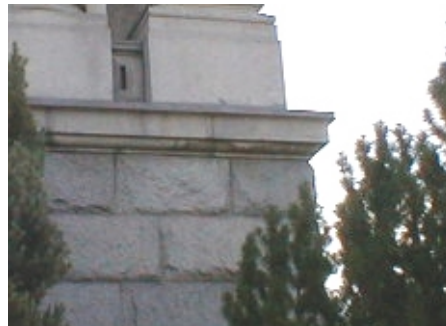
**Comments:** Mortar seems to be missing. Severe discoloration@ the joint of lower belt, also missing mortar.

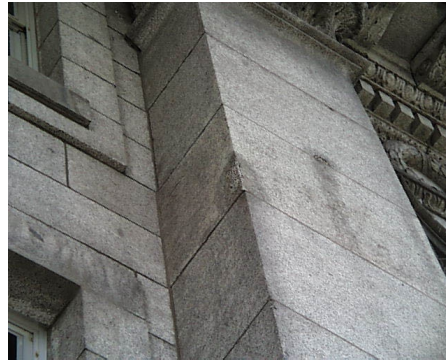
**Comments:** Typical bad patching on pilaster (West side).

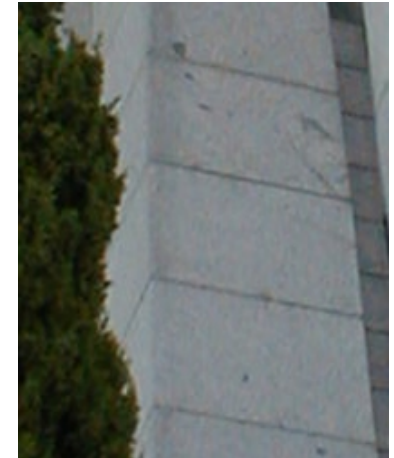
**Comments:** Bad patching.

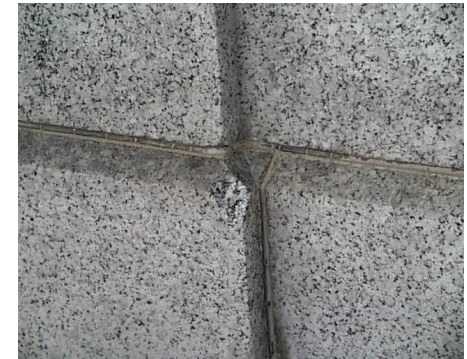
**Comments:** Small chips at the edge of pilaster..

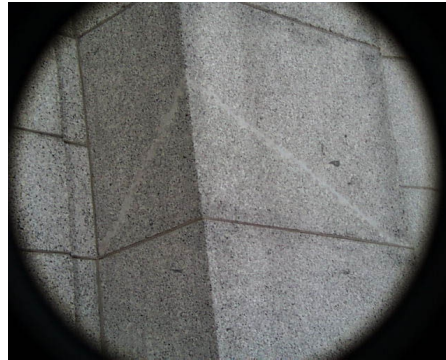
**Comments:** Bad patch on the cracking line

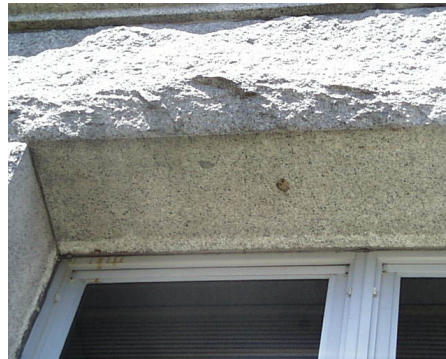
**Comments:** 11/2' little hole at end.

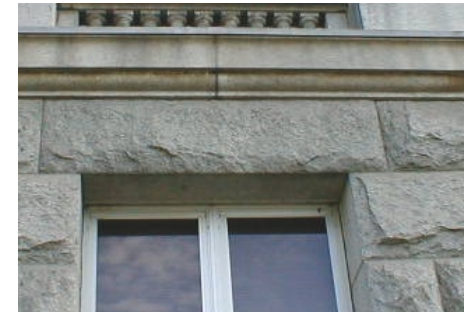
**Comments:** Hole, yellowish patch 1 1/2" dia.

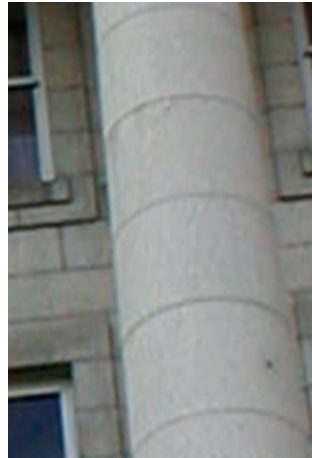
**Comments:** White patch- appears to have some cracking. Not sure if it's a patch- possibly an inclusion.

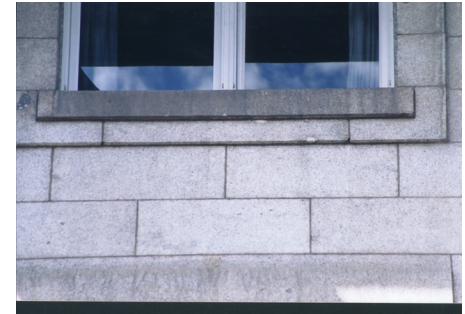
**Comments:** Two small white patches below the upper window trim (each 4"-5" across).

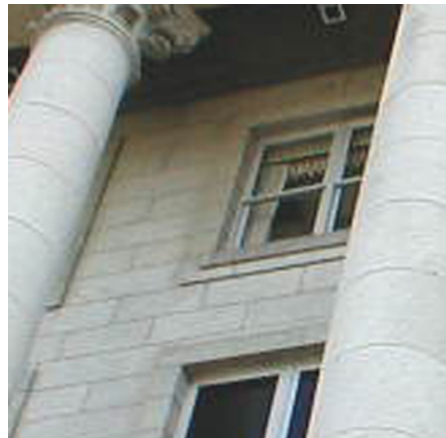
**Comments:** Small white patch (5" across) on wall to the left of the upper window.

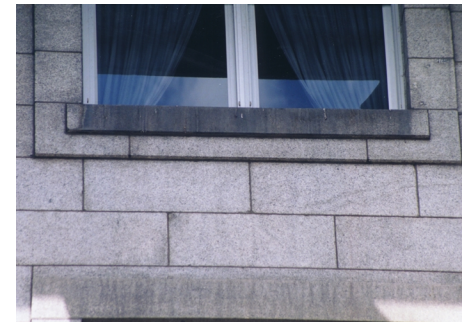
**Comments:** Water stains (especially bad on right) both sides of windows- more severe than on other windows.

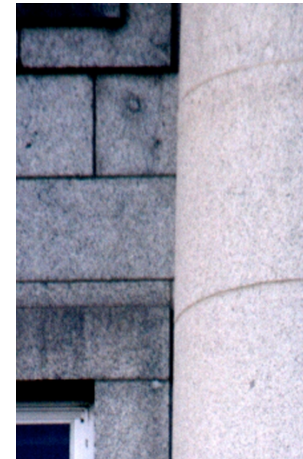
**Condition:** PAT

Poor quality, non-matching patch

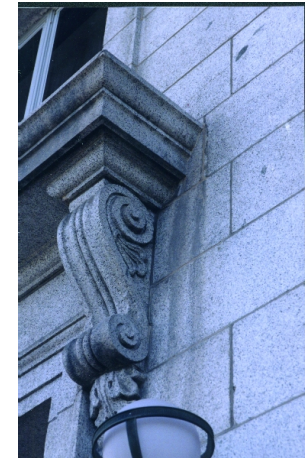
**Comments:** Staining at the door cornice

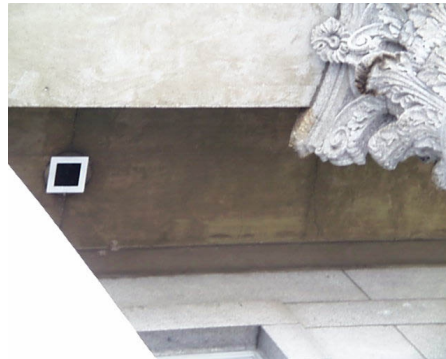
**Comments:** All across the west wing- cracks next to light fixtures.

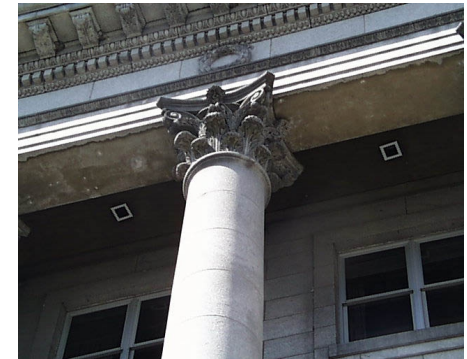
**Comments:** Stained all along west wing- under the entablature.

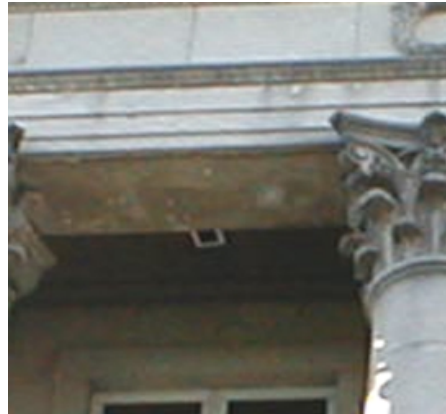
**Comments:** Small patches in three bays under the entablature.

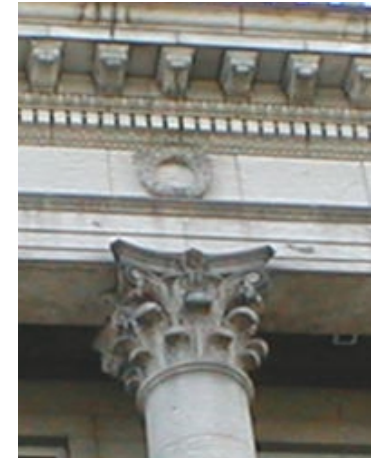
**Comments:** Bad patch

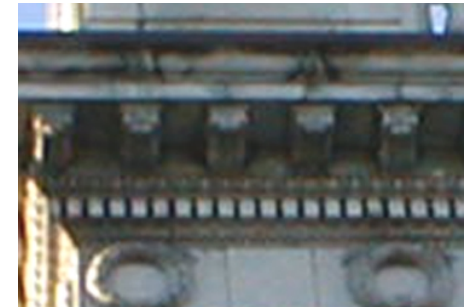
**Comments:** Bad dark stain- maybe a nest.

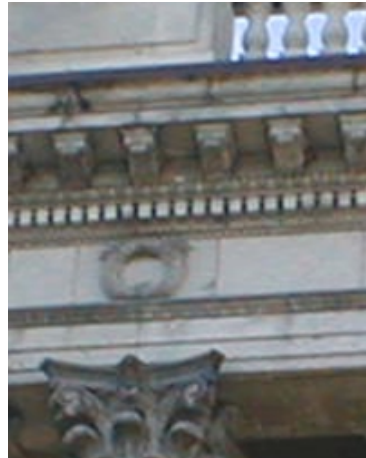
**Code:** EX-010**Description:** Entablature frieze**Location:** between brackets on frieze**Grid:** W 190.5-G**Condition:** PAT

Poor quality, non-matching patch

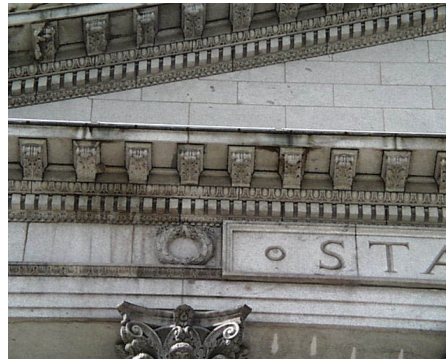
**Comments:** Bad patching.**Code:** EX-010**Description:** Entablature frieze**Location:** bracket**Grid:** W 21-G**Condition:** M

Missing element

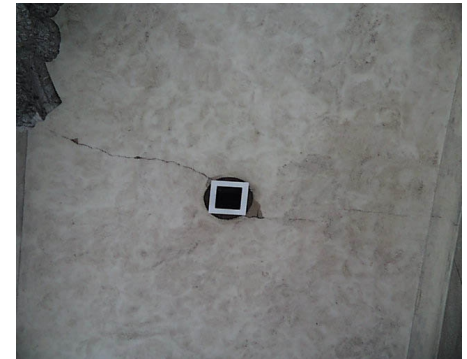
**Comments:** Ceiling cracking across the light fixture.

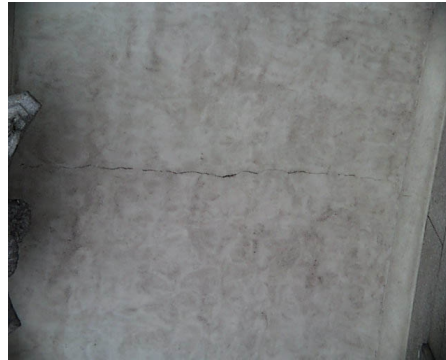
**Comments:** Ceiling cracking

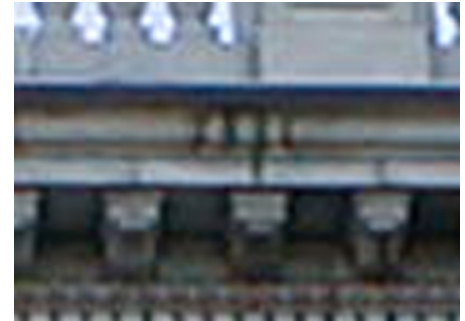
**Condition:** J  
Mortar joint with missing or loose mortar

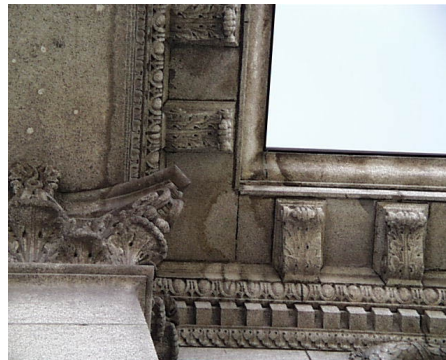
**Comments:** Two dark spots- general dark stains all along west wing- under cornice.

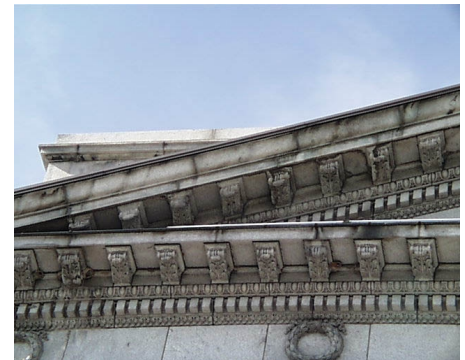
**Comments:** Water damage along the cornice (stain).

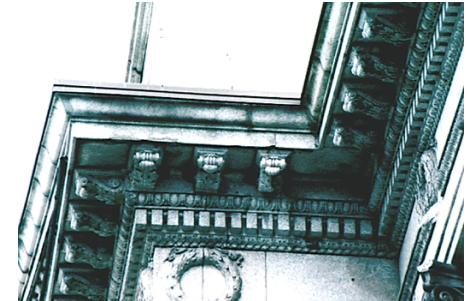
**Condition:** J, ST

Mortar joint damage and significant staining

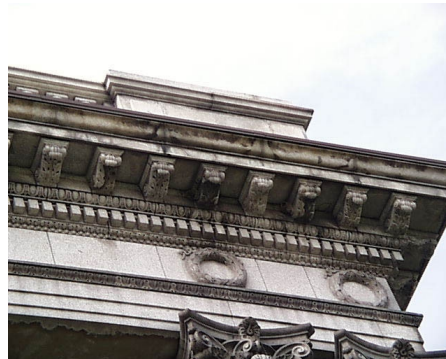
**Comments:** Bad water stain along cornice and some of the frieze.

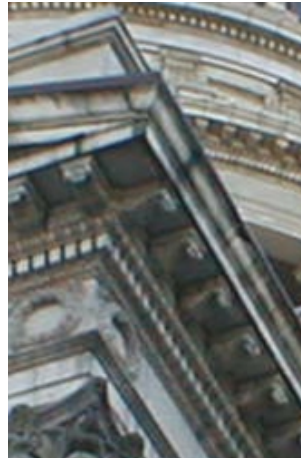
**Condition:** CR

Cracked element

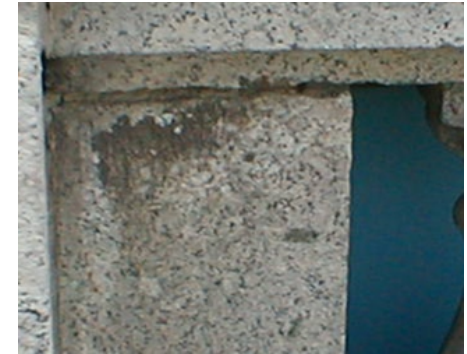
**Comments:** Small hole at baluster base

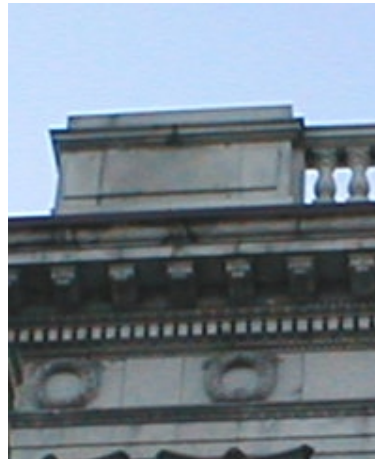
**Comments:** Stain under railing on balustrade/  
newel post- mortar missing.

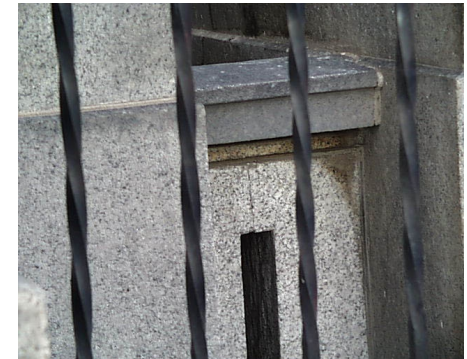
**Comments:** Cracking to baluster railing

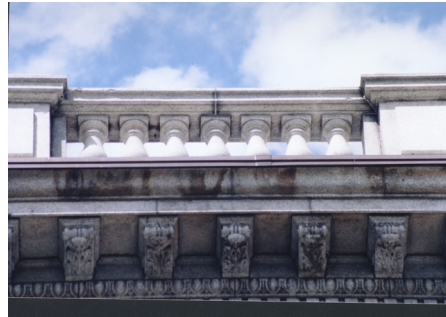
**Comments:** 2nd and 3rd Balustrade front chipped 2" dia/1" dia.

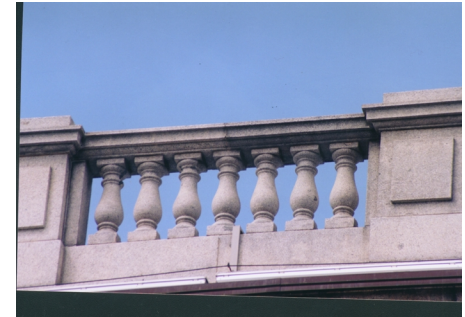
**Comments:** 1st balustrade chipped 1" dia and 4th looks granular.

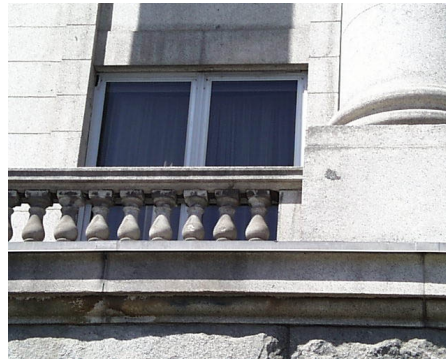
**Comments:** Chipped at front.

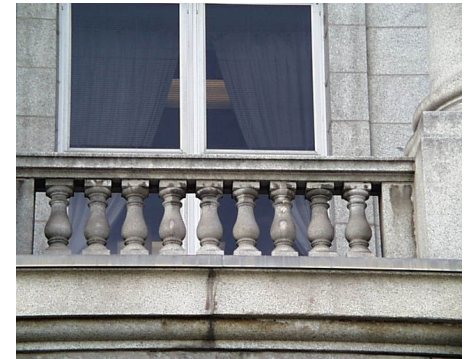
**Condition:** ST

Significant Staining; may indicate rusted connector

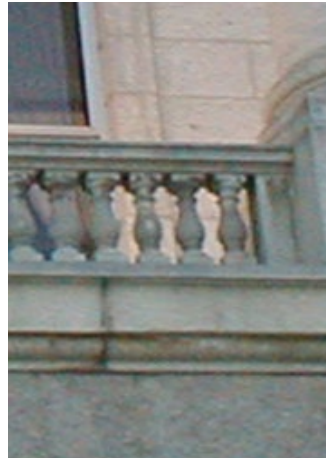
**Code:** EX-017**Description:** Balustrade baluster**Location:** baluster 4 & 7**Grid:** E 85.5-C**Condition:** PAT

Poor quality, non-matching patch

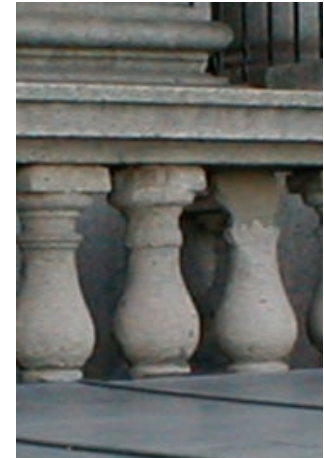
**Comments:** Cracked and missing chunk of balusters

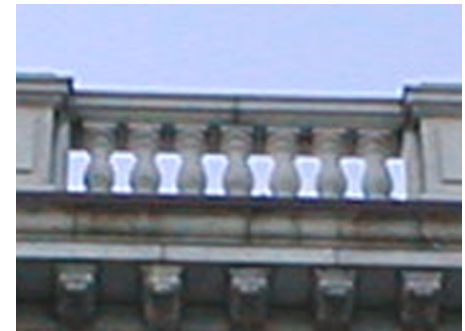
**Comments:** Small chips out of the balustrade railing edge in two sections of railing.

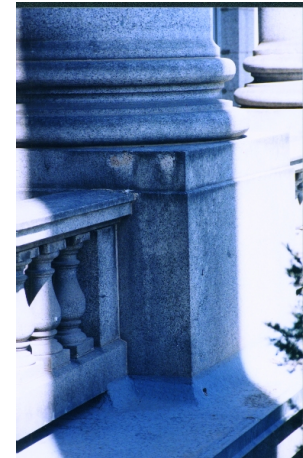
**Condition:** ST

Significant Staining; may indicate rusted connector

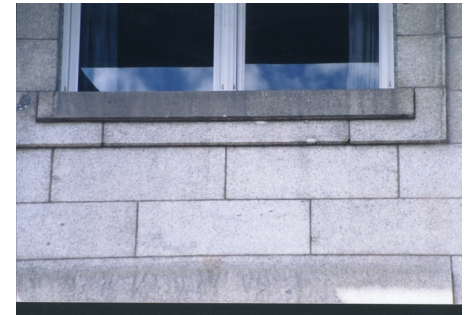
**Comments:** Dark water stain on upper window trim on all windows- lower trim of windows

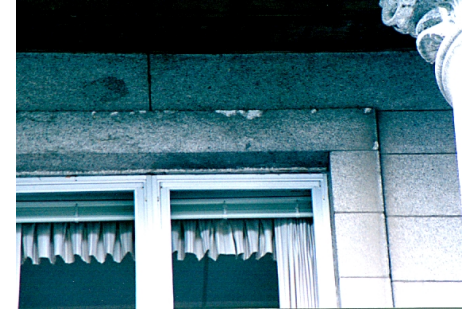
**Comments:** White water damage along top above windows- some also along side of windows.

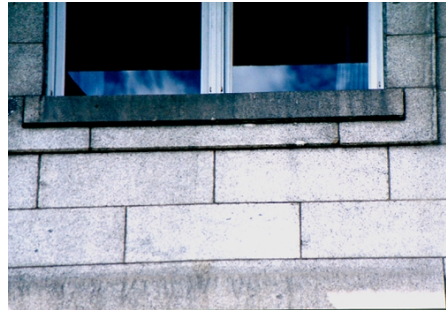
**Comments:** Looks like a rusty stain.

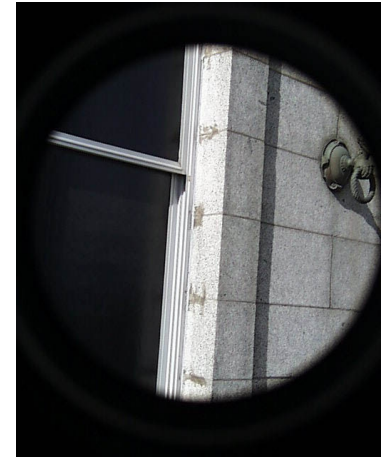
**Comments:** Bad glue or chemical stains on the joints of the window trims at lower windows.

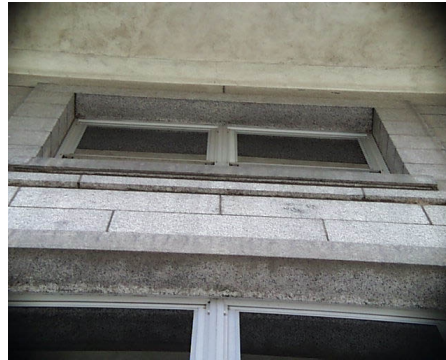
**Comments:** Water deposit at underside of upper and middle window trim.

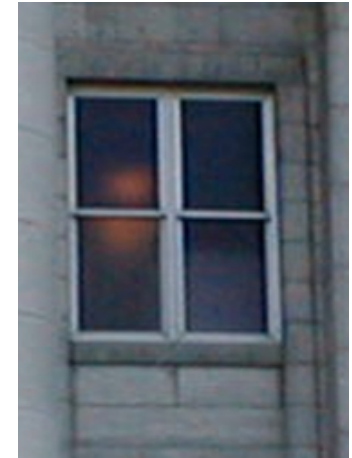
**Comments:** Damaged caulking.

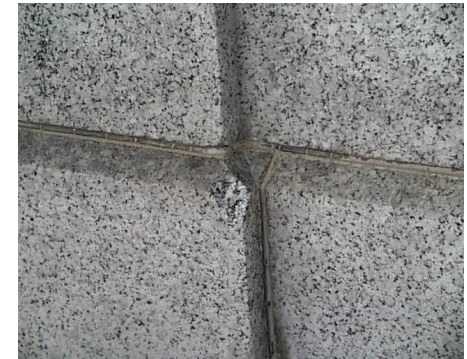
**Condition:** BR

Broken, severely cracked or chipped

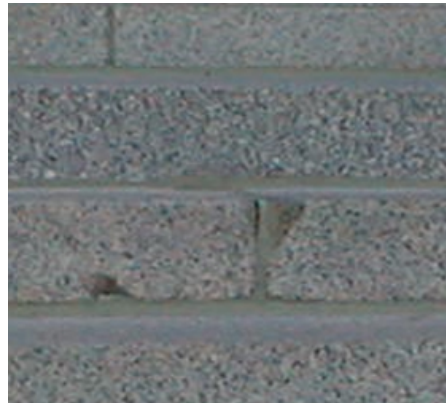
**Comments:** Chipped edge

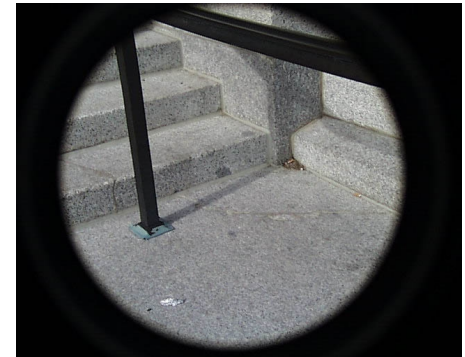
**Condition:** CR

Cracked element

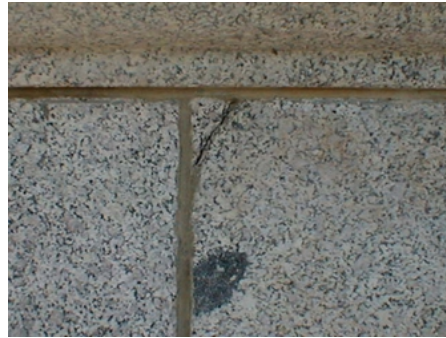
**Code:** EX-075**Description:** Railing**Location:** at the front of the guard rail**Grid:** W 35-B & C**Condition:** BRBroken, severely cracked or  
chipped**Comments:** Small cracks.

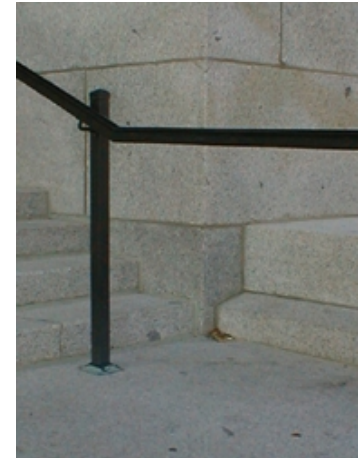
**Comments:** Front stair guard rail

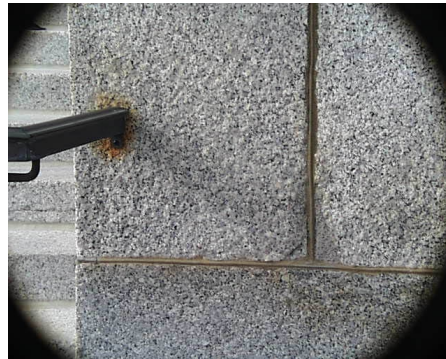
**Comments:** Metal guard rail is rusted, also a  
stain on the masonry guard rail.

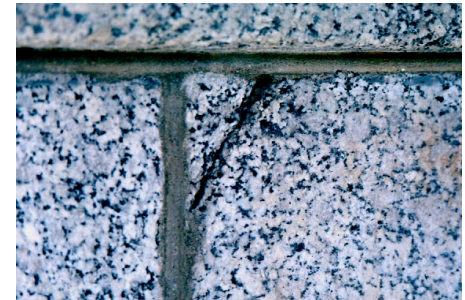
**Condition:** BR, PAT

Broken element, poor quality  
patching

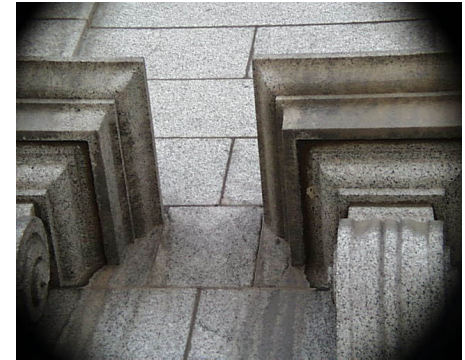
**Comments:** Water stains.

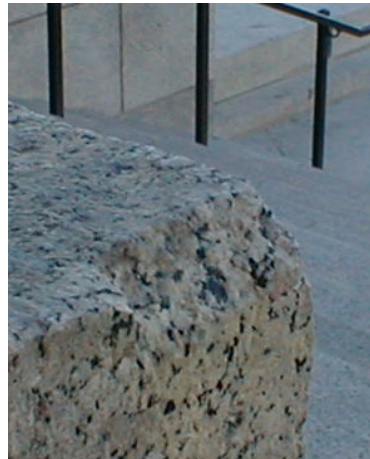
**Comments:** Small chips at the edge of the column base.

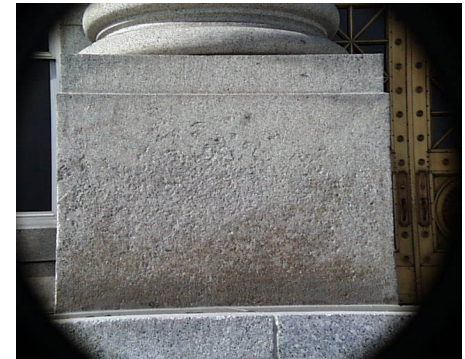
**Comments:** Seriously exfoliated surface and minor chip at the column base.

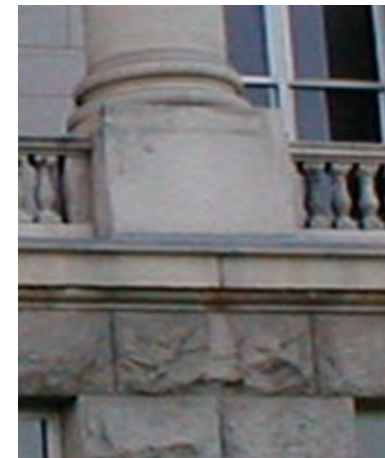
**Comments:** All along East windows

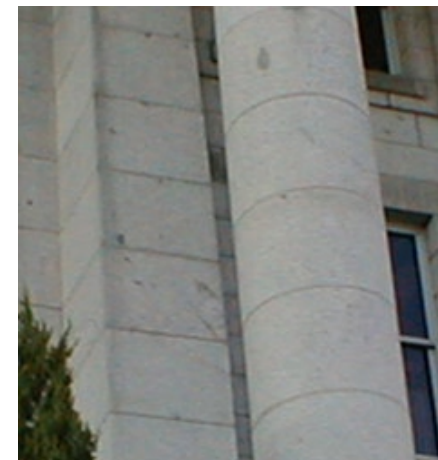
**Comments:** Small chips along joint.

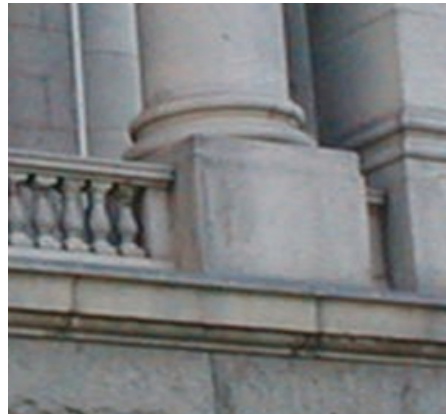
**Comments:** Two lines at the bottom of the ring shaft seem to indicate replacement items. Cracking
